# OT or Not?

Issues Concerning Over-temperature of Turbine's Blades

Capt. Nitzan David Foucks, Materials Div., IAF

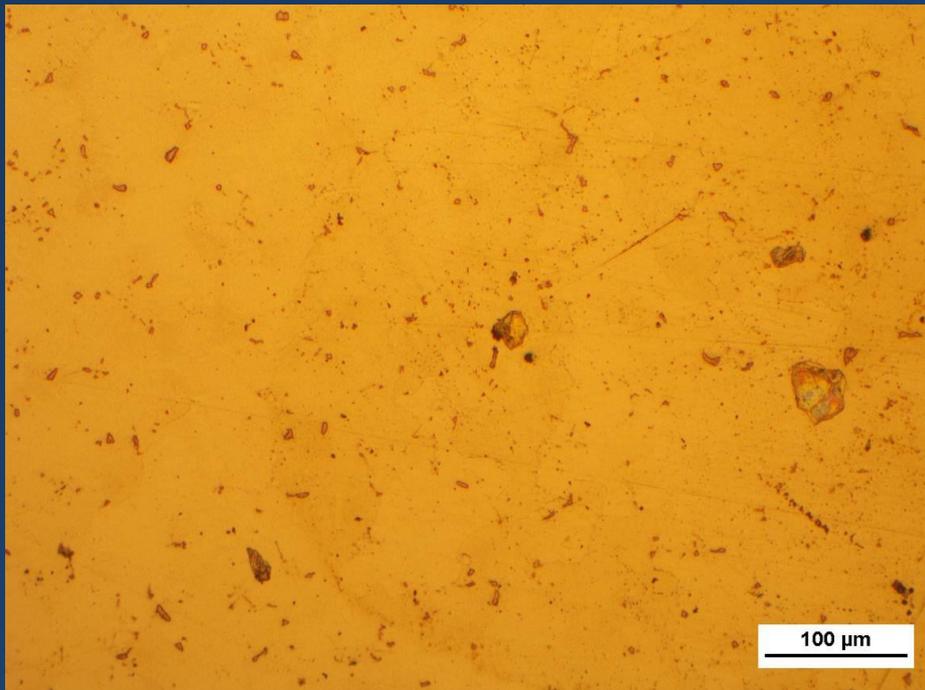
Airfoil - OT

- The M&P dept. position: The airfoil and the center of the airfoil has undergone OT
- The manufacturer's response: OT in the airfoil, no OT in the center of the airfoil but **time-dependent change** of microstructure

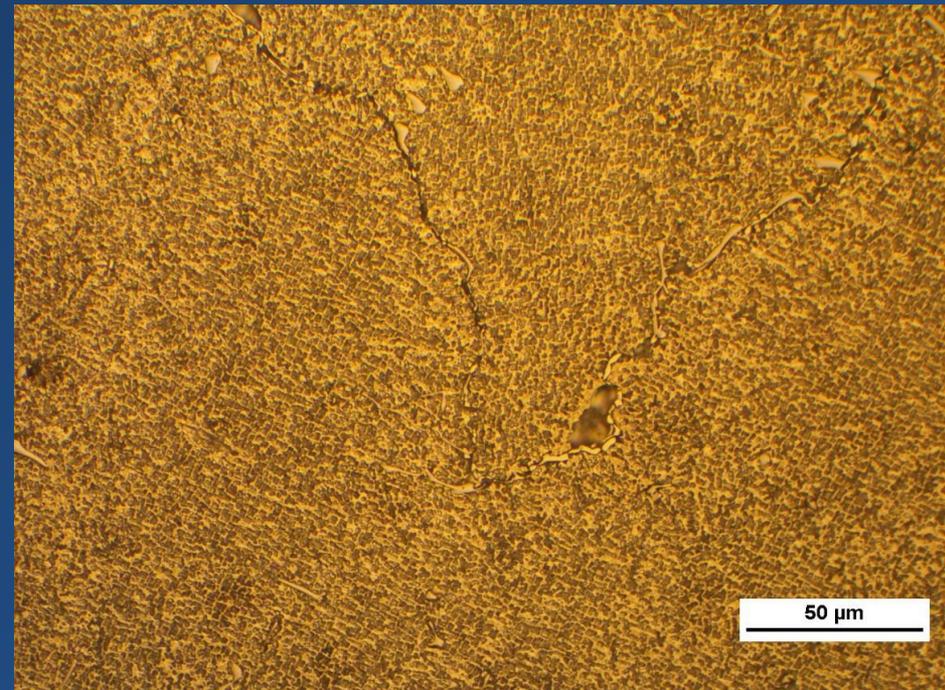
Root - No OT

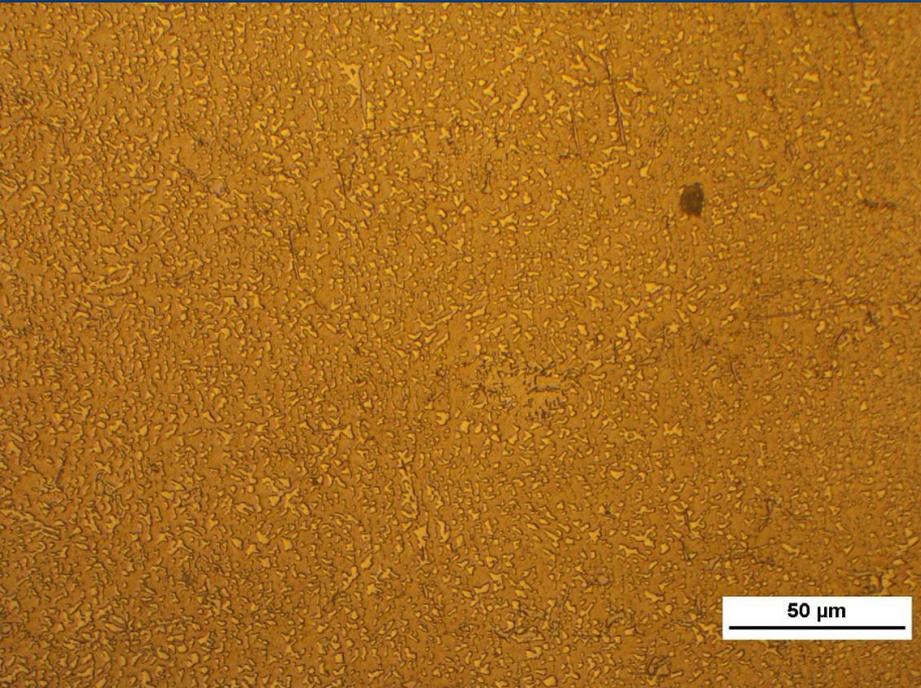
Center of Airfoil - ?

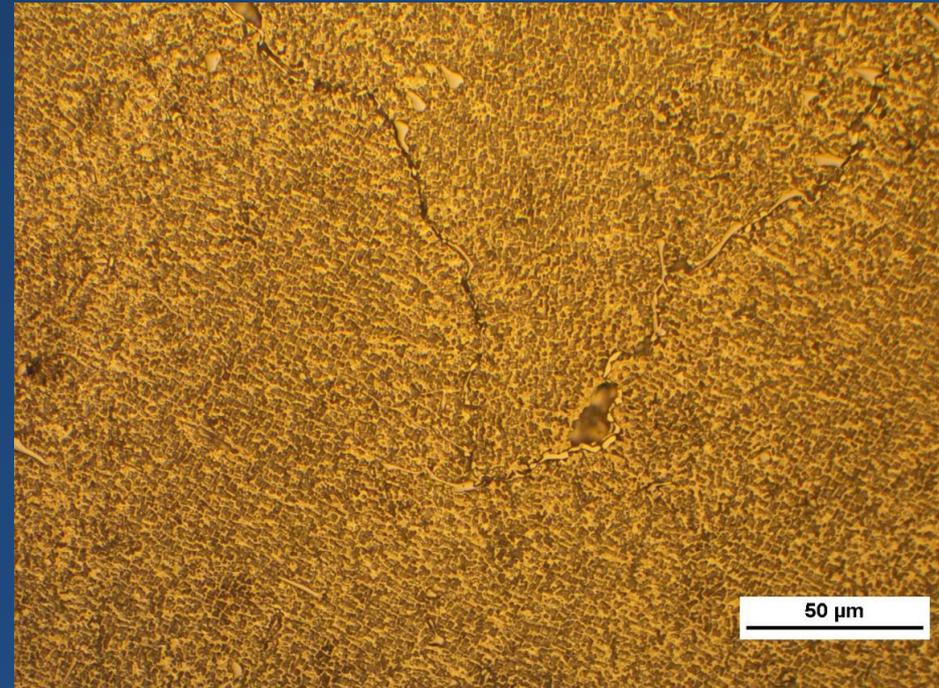
Root - No OT

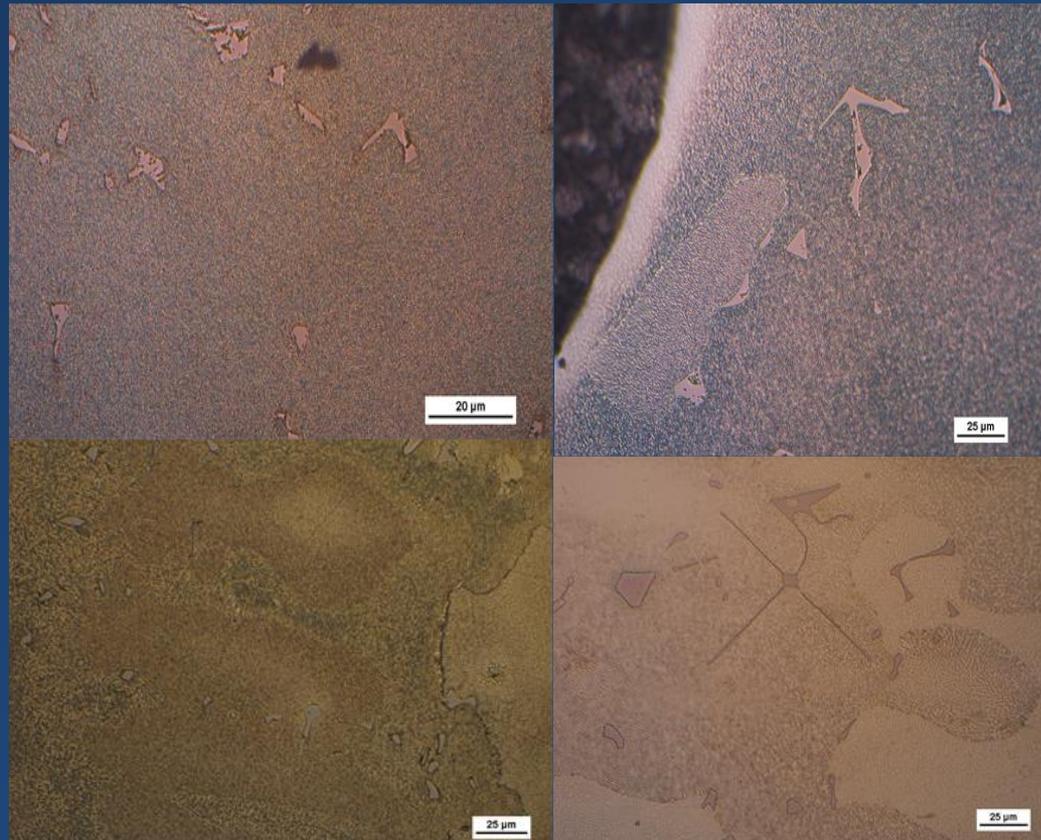
Microstructure of roots from 4 different blades

- There are changes in the microstructure, but they do not result from OT
- The probable causes for the changes might be due to casting or time-dependent changes
- IAF conclusion: No OT
- Manufacturer conclusion: No OT
