# OT or Not?

Issues Concerning Over-temperature of Turbine's Blades

Capt. Nitzan David Foucks, Materials Div., IAF

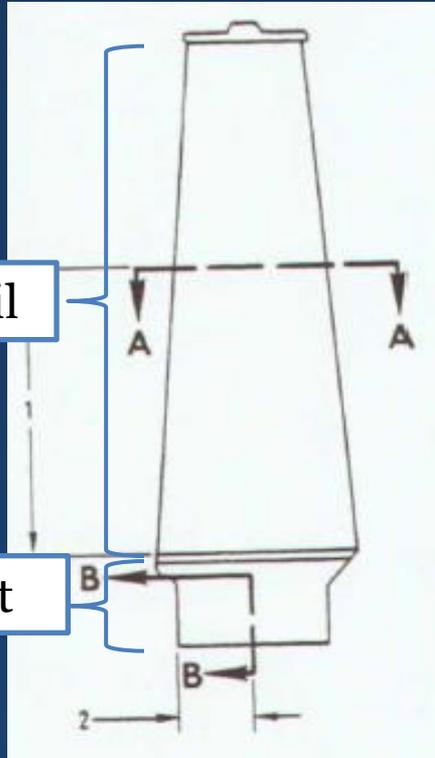
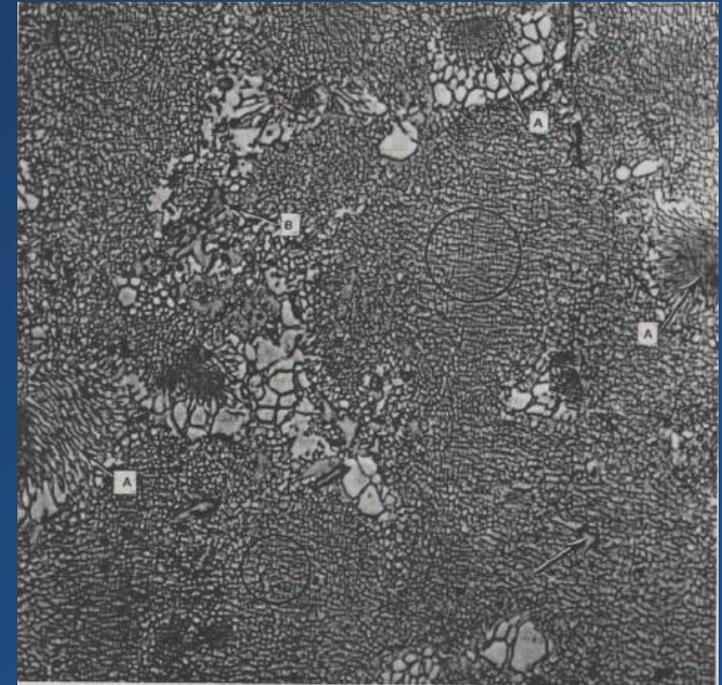
PWA 1455 Material After Attaining Metal Temperature of Less than 2000°F (1094°C) Exhibiting Typical Uniform Array of Matrix Gamma Prime Precipitate (Circled Areas), Gamma-Gamma Prime Eutectic Islands (A), and MC-type Carbides (B)  
Figure 1 (1000X)

- In order to determine if there is OT, the microstructure of the root is compared to the microstructure of the airfoil

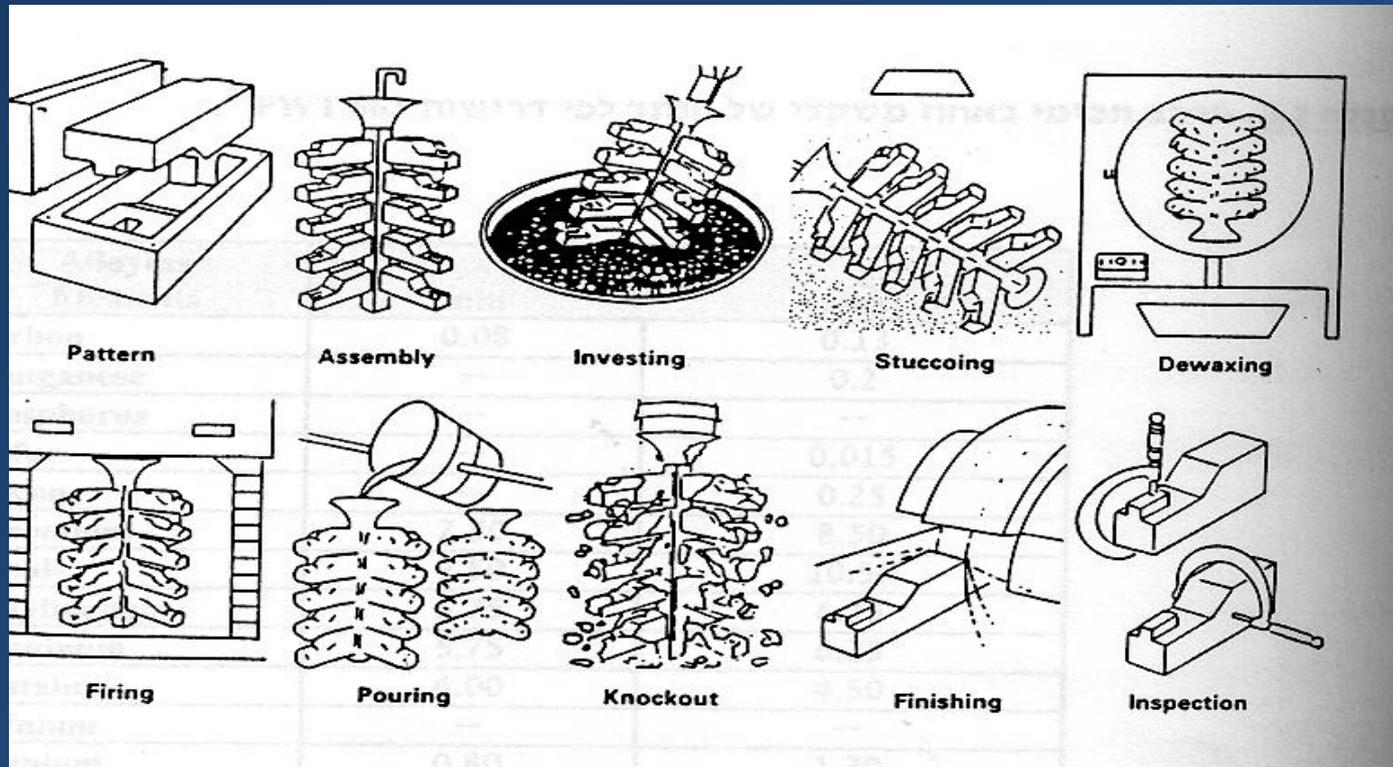
- Service time
- Manufacturing process - casting

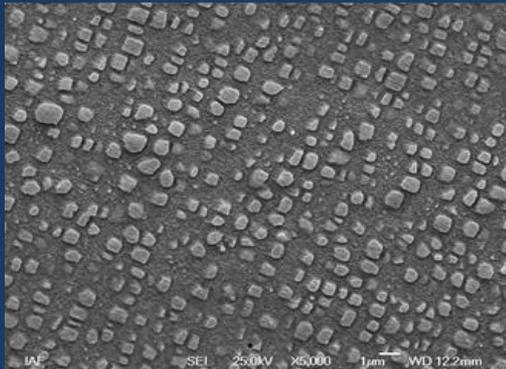
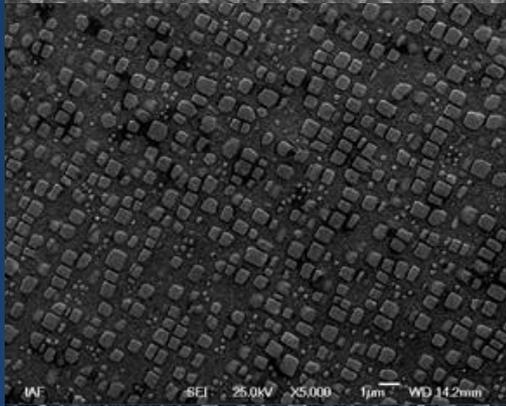
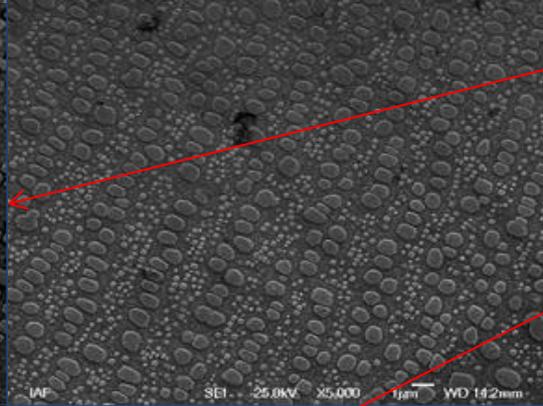
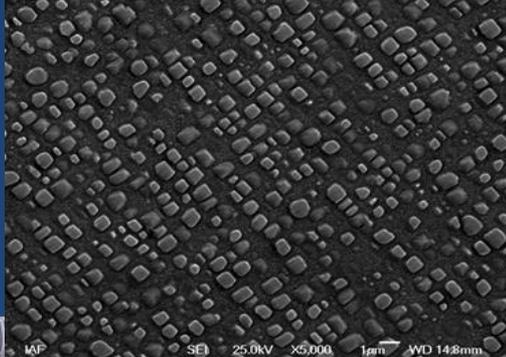
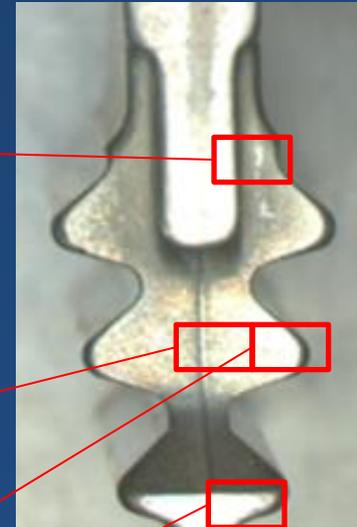
- There are changes in the microstructure, but they do not result from OT
- The probable causes for the changes might be due to casting or time-dependent changes
- IAF conclusion: No OT
- Manufacturer conclusion: No OT
